## Vulnerability Assessment of Buildings against Earthquake Case Study: Qadghoon Neighborhood, Borujerd, Iran

**INTRODUCTION:** The buildings, as the main and most abundant elements in cities, have great importance in two aspects of assessing and mitigating the vulnerability at disaster incidence. On the other hand, the emphasis of post disaster reconstruction engineers on the single-scale building has compounded the importance of building in terms of planning to reduce the damages of disaster incidence.

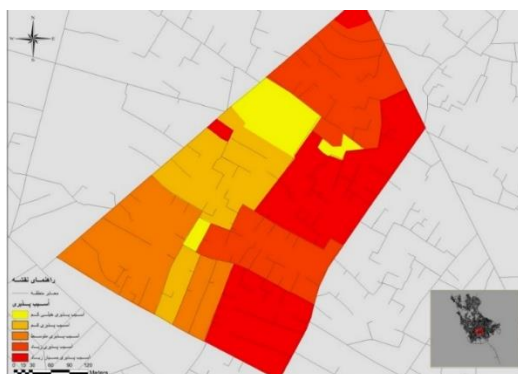
**Figure 5.** Location of blocks with irregular and unconventional buildings (authors)

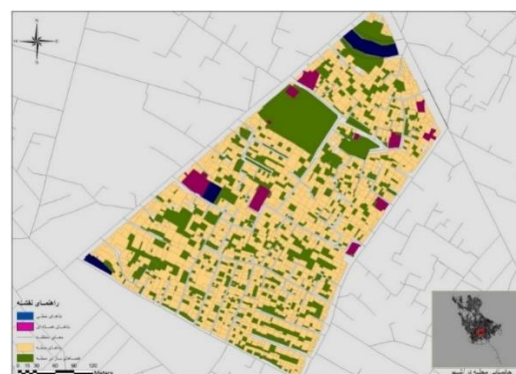
**Figure 6.** Locating various forms of public buildings (authors)

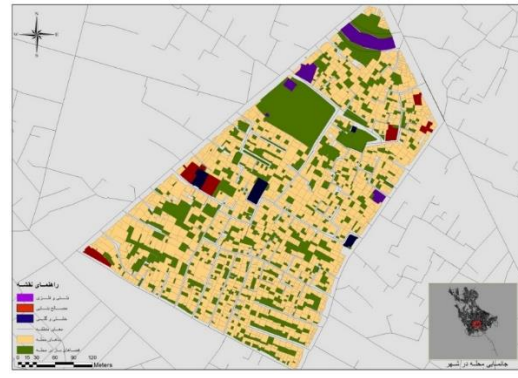
**Figure 10.** Locating types of construction technology (authors)
